12. RECEIVING ONSHORE ENVIRONMENT: LNG FACILITIES

12.1 Introduction

This chapter provides a description of the onshore physical and biological environment associated with the LNG Facilities site and environs.

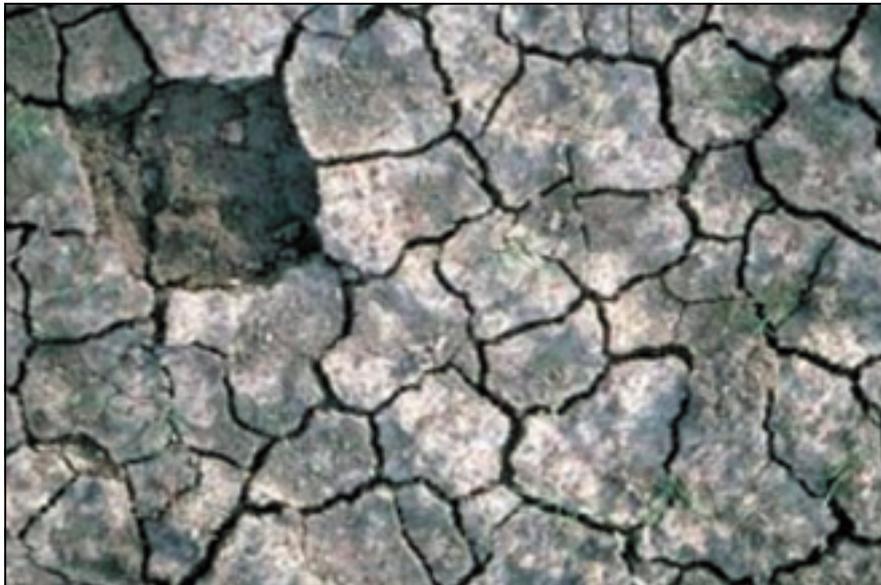
Plate 12.7
Black cracking clays (vertisols) on the site

alluvial or colluvial deposits. Vertisols are uniformly textured soils with a high clay content and very low permeability, and are subject to shrinking and cracking on a seasonal cycle associated with wetting and drying. They are known as 'black cracking clays' and may be dispersive and highly eroded if disturbed (Plate 12.7). Usually vertisols have a high sodium content (sodic soils) that additionally causes the clays to swell and disperse. These soils persist across most of the LNG Facilities site. The surface clays form polygonal cracking patterns that can become over-consolidated with material falling into the cracks. In the wet season, these cracks close resulting in pressures that can cause the ground surface to heave. Cracks have been noted up to 50 mm wide and up to 0.5 m deep. Sometimes when water drains into open cracks causing the clay to erode, crabholes (erosion holes) develop in the clay surface.

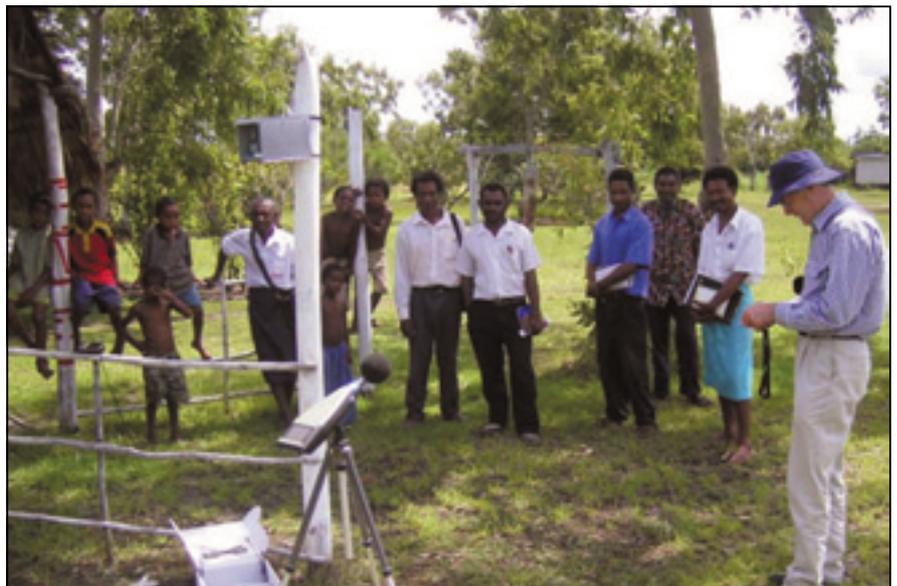
Plate 12.12
Noise and air quality monitoring equipment
at Metago Bible College

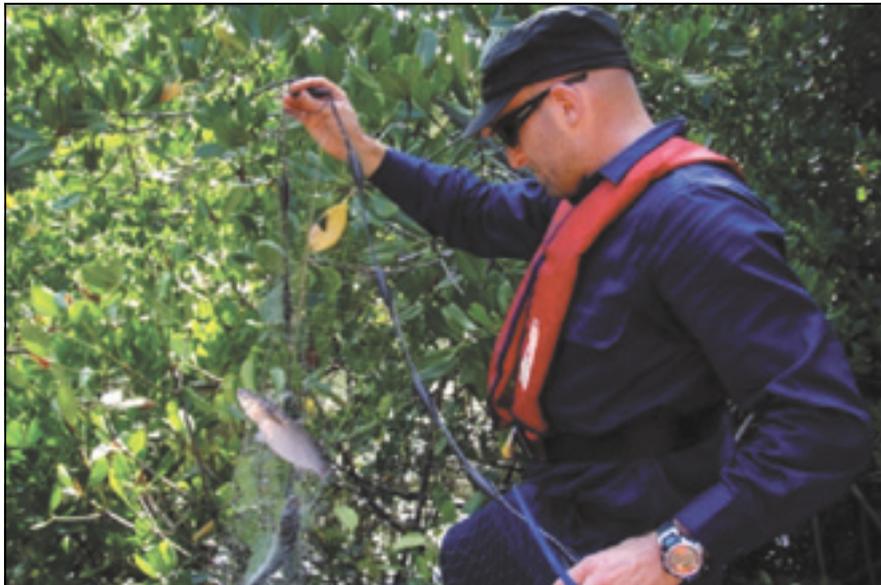
Plate 12.22
Gill netting to sample fishes

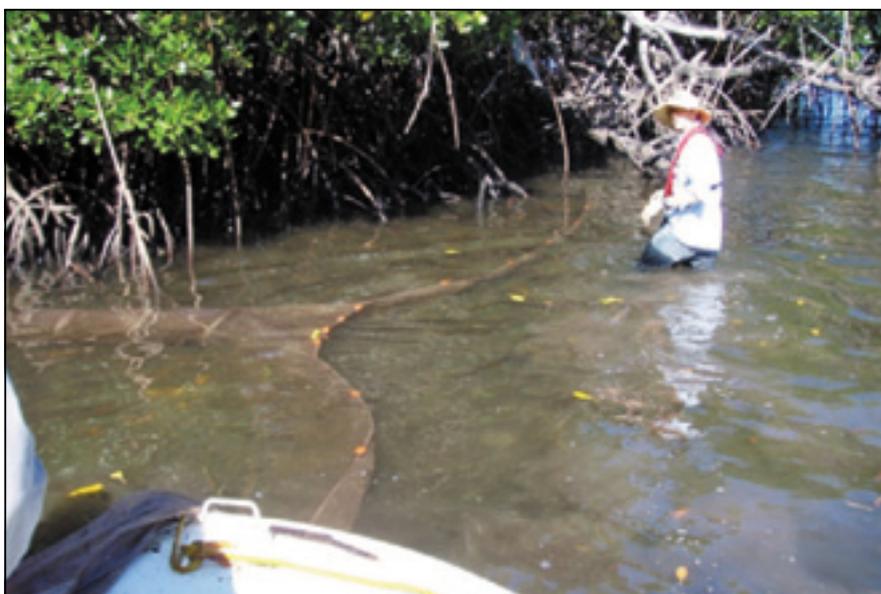
Plate 12.23
Fyke-net recovery at high tide
