13. RECEIVING MARINE ENVIRONMENT: MARINE FACILITIES

This chapter summarises the physical (Section 13.2), biological (Section 13.3) and resource utilisation (Section 13.4) characteristics of the nearshore marine environment traversed by the LNG Project Gas Pipeline, shipping access channel and marine facilities (i.e., LNG Jetty / Materials Offloading Facility) in Caution Bay (see Figure 4.1).

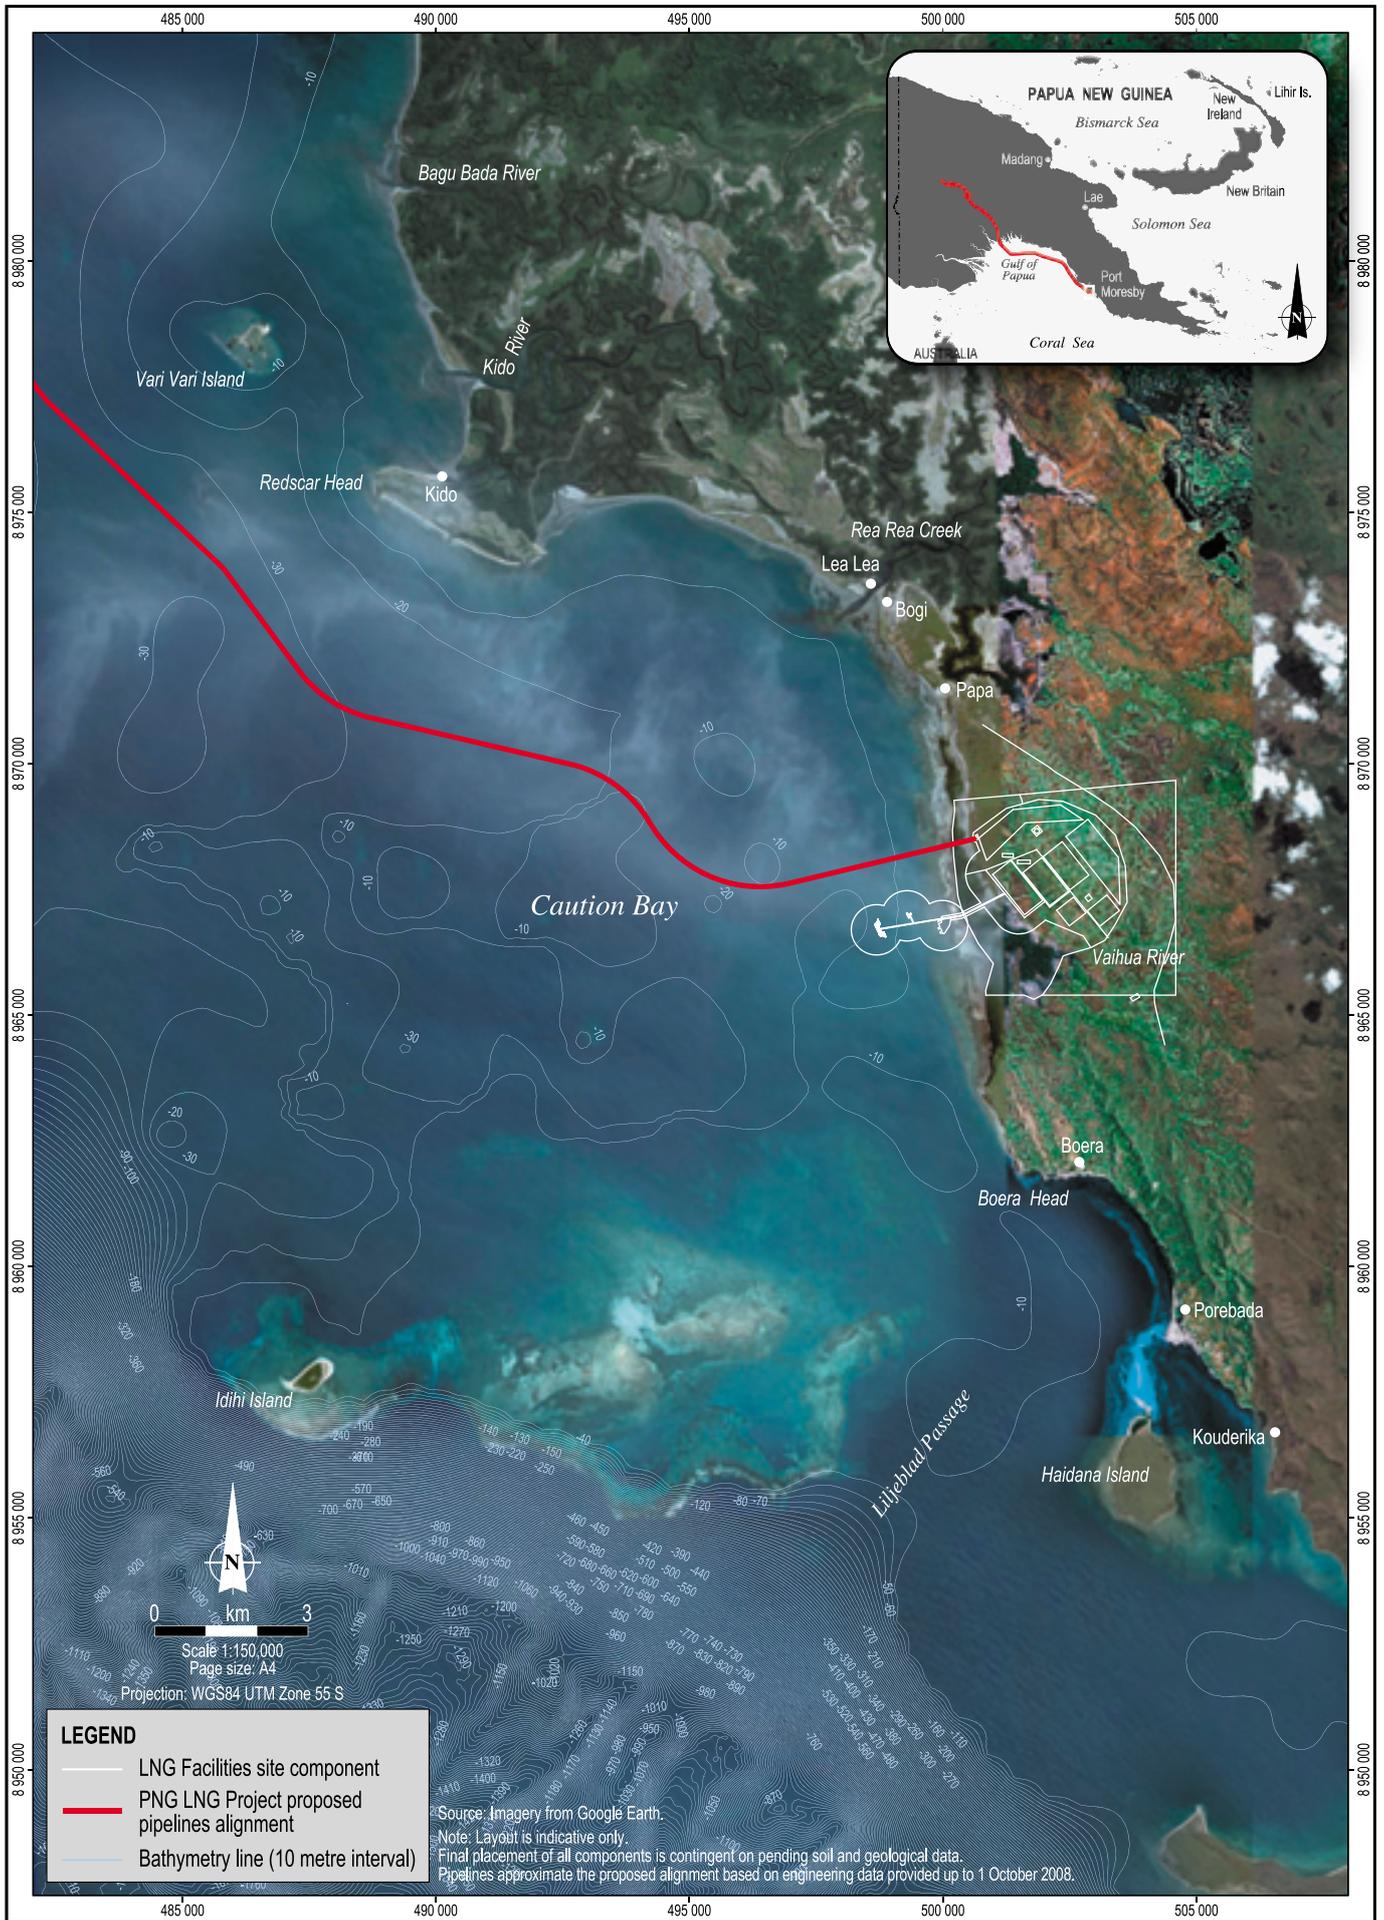
Date: 23.06.2008 MXD: PNG_LNG_Project_GIS.mxd File Name: 1284_09_F13.01_GIS_HB	Esso Highlands Limited	Caution Bay	Figure No:
		PNG LNG Project	13.1

Caution Bay (Figure 13.1) is a shallow coastal basin, situated approximately 20 km northwest of Port Moresby. Within the area of nearshore marine components of the project, the majority of the seafloor is characterised by terrigenous silt and clay sediments with evidence of epibenthic faunal activity in the form of mounds and burrows, which range in size and abundance across the seafloor. The deeper waters (i.e., 30 m to 50 m water depth) have a predominately muddy seafloor and a generally sparse distribution of visible biota. The shallow areas of seabed (i.e., less than 30 m water depth) closer to the coast are characterised by coarser coral sands and coral rubble.

The bathymetry of Caution Bay is complex with the existence of coral reefs and channels. Caution Bay has a wide, westerly facing entrance between Redscar Head and Idihi Island, inshore of which the bathymetry gradually shelves from around 50 m to less than 5 m at the nearshore fringing reef (see Figure 13.2). Within the bay, average depths are around 25 m, with many shallower coral bommies, mostly in the southern part of the bay. To the south and east of Idihi Island, the outer barrier reef forms the southern boundary of Caution Bay, beyond which, the seafloor depth drops rapidly off the continental slope to depths below 1,000 m about 3 km offshore of the barrier reef (see Figure 13.1).

As discussed in Section 13.2.1, Physiography, the two main offshore islands located within Caution Bay are Idihi Island and Vari Vari Island (see Figure 13.1). Vari Vari Island is situated to the north and is a remnant of the mainland, supporting an extensive fringing reef. Idihi Island is a coral cay, and is located to the south on the barrier reef. The coral at both Vari Vari Island and Idihi Island appear to be in good condition with high coral cover and diversity observed and no veneer of sediment. The offshore islands have a greater diversity and abundance of hard corals and fewer abiotic features than all other sites sampled in Caution Bay, although the results in terms of percentage cover of coral appeared to underestimate the overall visual impression at these locations (possibly due to the lack of sediment veneer). Both site CF-3 at Vari Vari Island (Plate 13.13) and site CF-4 at Idihi Island (Plate 13.14) show hard coral cover of 37% and 32% respectively. There are no signs of anthropogenic disturbance or disturbance from natural sources at these two sites, which would suggest that dynamite has not been used there for fishing.

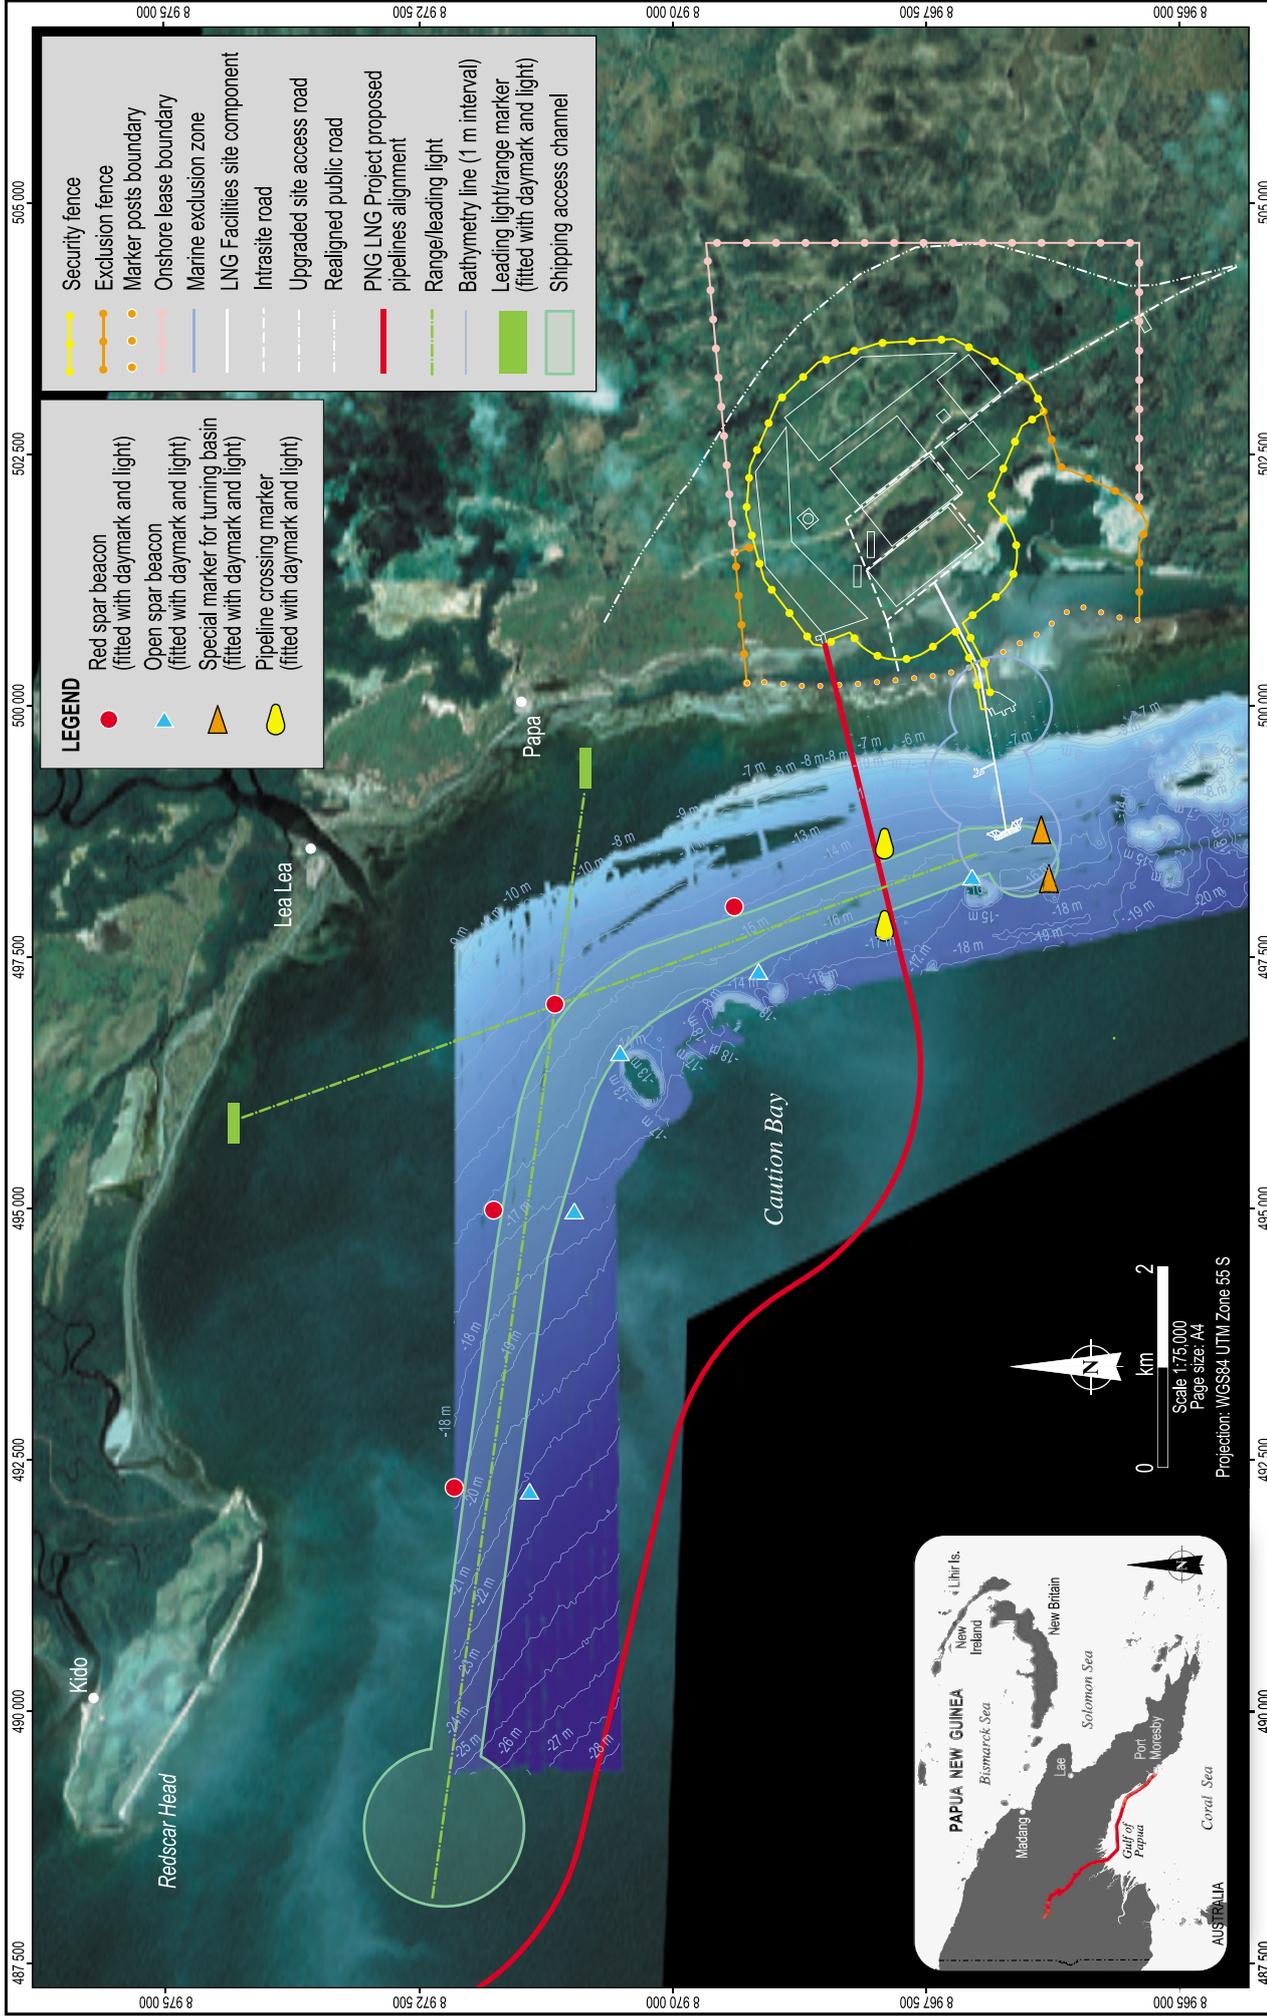
Figure No: **13.2**

An outer barrier reef forms the southwestern (offshore) boundary of the bay and provides protection from ocean swells. There are natural openings in the reef to the north of Idihi Island, which effectively marks the northwestern extent of the barrier reef, and to the south (Liljeblad Passage), which are used by small vessels to move in and out of the reef. The proposed access for LNG carriers is via the entrance to the north of Idihi Island, south of Redscar Head, and along a natural channel of at least 14 m depth that is devoid of shoals or bommies running south as far as the LNG Jetty (Figure 13.2).

Detailed bathymetry of Caution Bay

Within Caution Bay, a natural channel of at least 14 m depth and free from coral bommies runs between Redscar Head and Idihi Island and generally follows the alignment of the coast until reaching the area adjacent to the proposed LNG Jetty. This provides adequate access and depth for the LNG carriers without need for dredging along the shipping access channel. However, some dredging may be required to provide even depth of 14 m within the turning circle – see Section 4.6.1.10, Dredging for the Marine Facilities); and dredging will be required to provide adequate depth access to the Materials Offloading Facility. Further to the south, numerous shoals and bommies rise to about 5 m below the water surface (see Figures 13.1 and 13.2). In the 20-km-long segment of the offshore pipeline route that runs through Caution Bay, the seafloor depth reaches 47 m at the seaward margin.

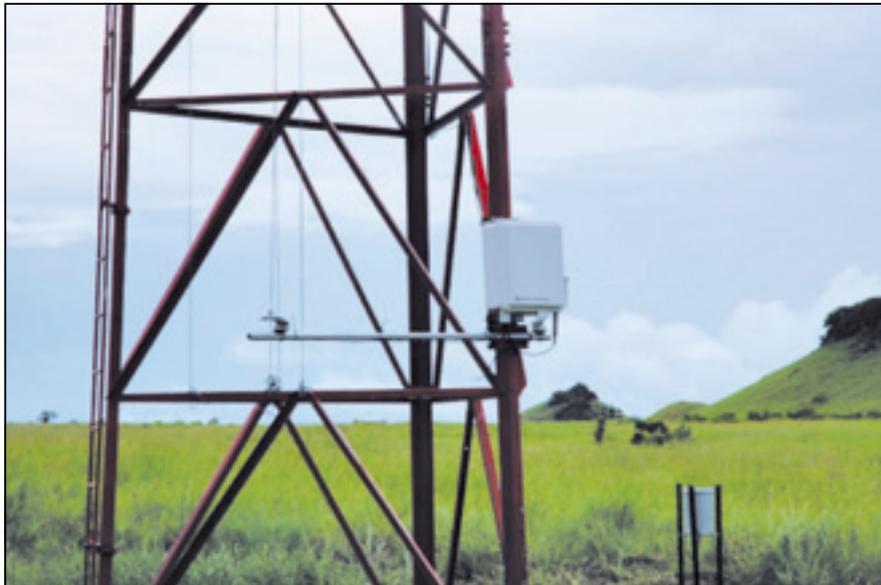
Plate 13.1
Automatic weather station near
Caution Bay coast

An automatic weather station (AWS) was deployed on land near the coast of Caution Bay in February 2008 (Plate 13.1). The location on land may reflect some influence of land–sea effects (of cliffs and hilly topography) and cause some local differences with respect to offshore winds. Notwithstanding, the climate of the region is dominated by two main seasons. The northwest monsoon season extends from December to March, and the southeast trade winds extend from May to October; November and April are transitional months.

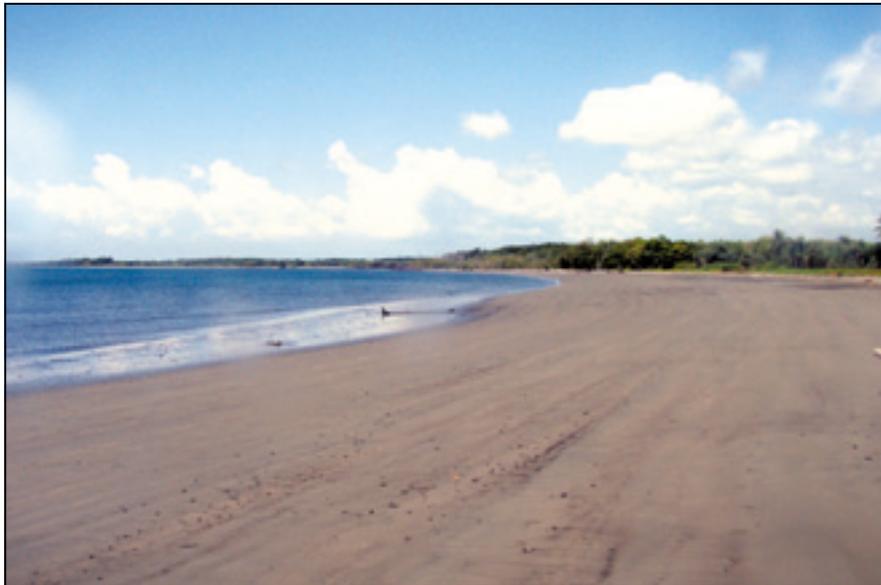
Plate 13.4
Small patches of sandy beach along
the southern coast of Caution Bay

Sandy beaches occur in small patches along the southern coast of Caution Bay in regions not supporting mangroves. An extensive sandy beach occurs in northern Caution Bay, and a wide beach is also present north of the Kido River (Plate 13.4).

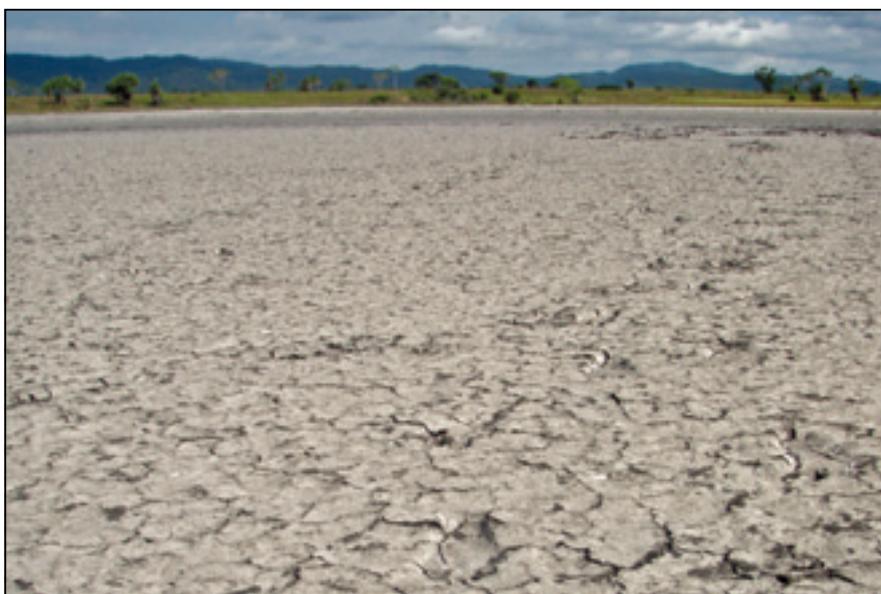
Plate 13.5
Supratidal mudflats / saltflats

Supratidal mudflats and saltflats are located behind the mangroves along the Vaihua River (Plate 13.5). These areas are barren of vegetation as they are only inundated infrequently. Further information about this habitat is provided in Section 12.4.2.2, Hypersaline Wetland (Saltflat) Habitats.

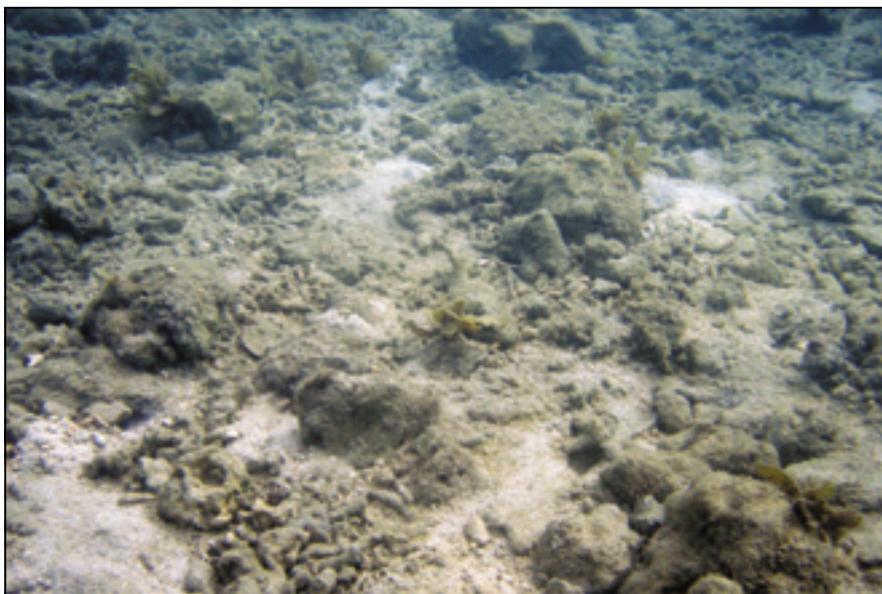
Plate 13.8
Dead coral and rubble

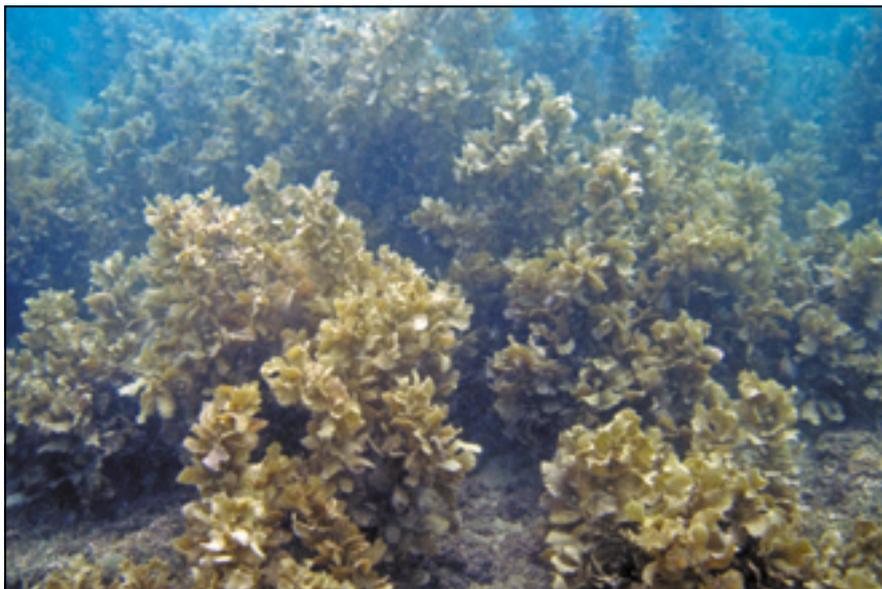
Plate 13.9
Reef top dominated by brown algae
(*Sargassum* spp.)

The condition of the majority of the fringing reef in Caution Bay is poor, with generally low coral cover, extensive areas of abiotic substrate and visible veneers of sediment. Much of the reef is dominated by brown algae (*Sargassum* spp.) (Plate 13.9). Although *Sargassum* is a common algal component of tropical reefs and lagoons (Womersley, 1987; Cribb, 1990; Vuki & Price,

1994), it now occupies extensive areas around the crest of the fringing reef. It is not clear whether the *Sargassum* has increased by gradual replacement of degraded coral on the fringing reefs of Caution Bay or whether this is a natural condition. Nutrient levels were within typical ranges (see Section 13.2.4.1, Water Quality) and not suggestive of a possible cause.

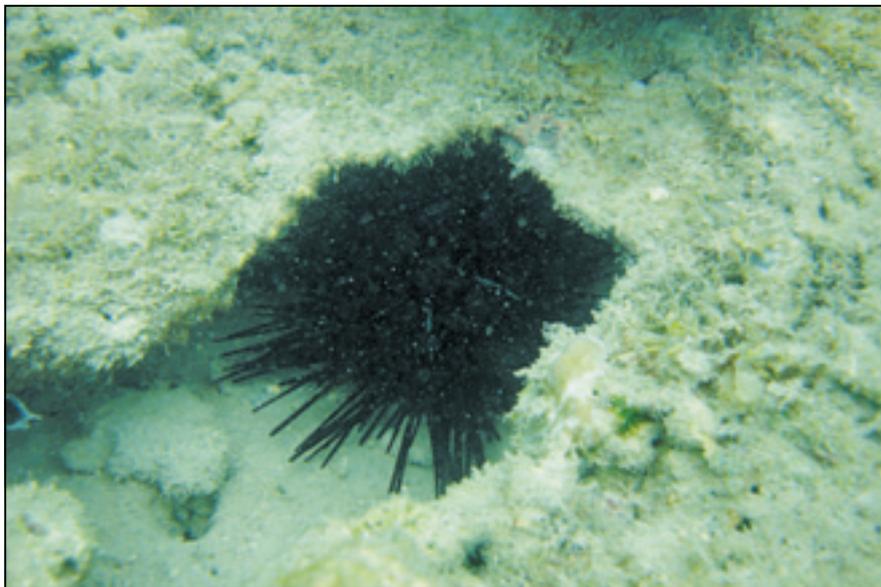
Plate 13.10
Sea urchins (*Diadema* spp.) in Caution Bay

The inshore fringing reefs also have high densities of the sea urchins (*Diadema* spp.) (Plate 13.10), which is often indicative of the lack (most likely through high fishing pressure – see Section 13.4.1, Subsistence Fisheries) of higher-order predatory species, such as predatory fish and octopus (Steiner & Williams, 2006). The grazing by *Diadema* spp. in turn adds to the reduction of coral settlement and recovery.

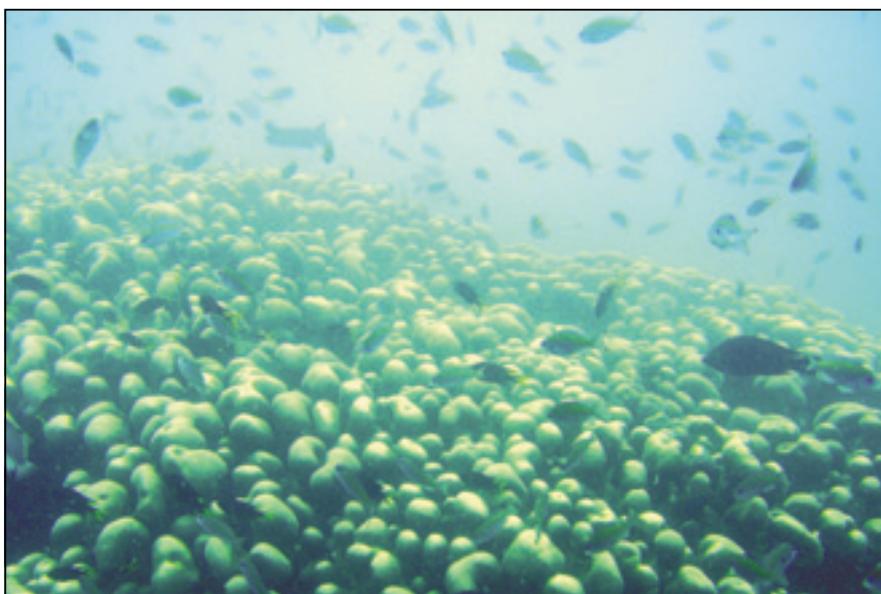
Plate 13.11
Fish abundance on *Pavona clavus* bommie

The *P. clavus* bommie (Plates 13.11 and 13.12) is 16.75 m in diameter and approximately 3 m high. *P. clavus* is a common coral with a wide distribution across the Indo-Pacific region. This species is known to grow very large, several metres in diameter, and form large mono-specific stands or reefs. Other examples of very large individuals (larger than 15 m in diameter) of this species have been recorded in the literature, such as a colony from Urvina Bay, Galápagos (Benway, undated); but specimens of this size are not common.

Unlike most other nearshore coral reef areas of Caution Bay, the proportion of live coral cover across the *P. clavus* bommie is very high (up to 100%), and the coral is in a healthy condition (see Plates 13.11 and 13.12). The bommie supports high fish densities, including large numbers of Lutjanidae (snapper), which are not as commonly sighted at other sites in Caution Bay.

A single bommie of unusual appearance (on sidescan sonar) was first observed during a geotechnical survey and subsequently investigated by divers. This bommie consisted of a single large *Pavona clavus* coral colony (see Figure 13.5) and was in excellent condition despite being located in only 8 m of water in an area of sandy seabed, away from other coral bommies. Its condition is in such contrast to the corals in other areas that it may not be well known to fishermen.
